Name Of Dam: GOSHEN DAM

Location: ROCKBRIDGE COUNTY, VIRGINIA

Inventory Number: VA. NO. 16301

PHASE I INSPECTION REPORT

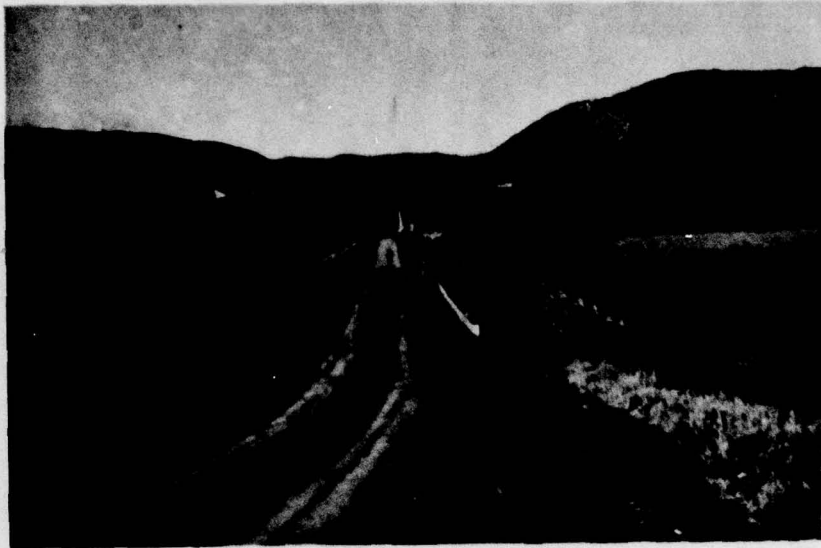
OVERALL VIEW - EARTHEN BERM
(VIEW FROM EASTERN ABUTMENT)

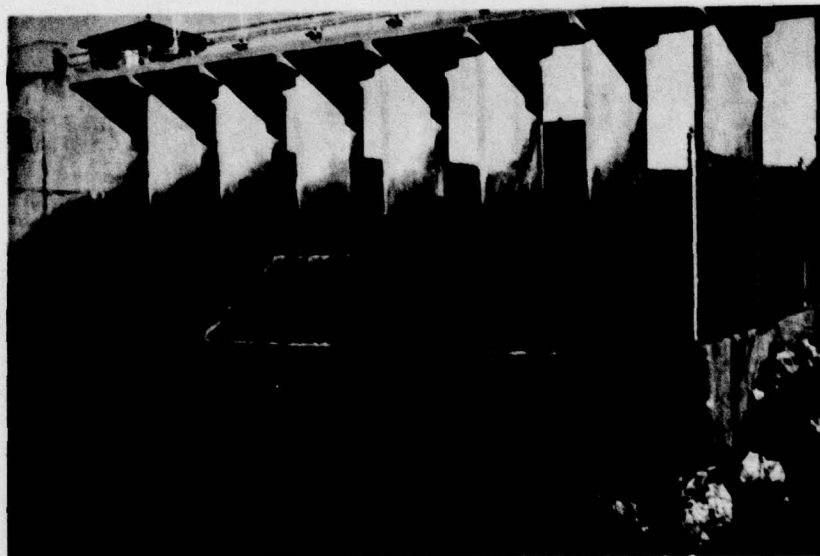
OVERALL VIEW - GATES AND SPILLWAY
(VIEW FROM DOWNSTREAM CHANNEL)

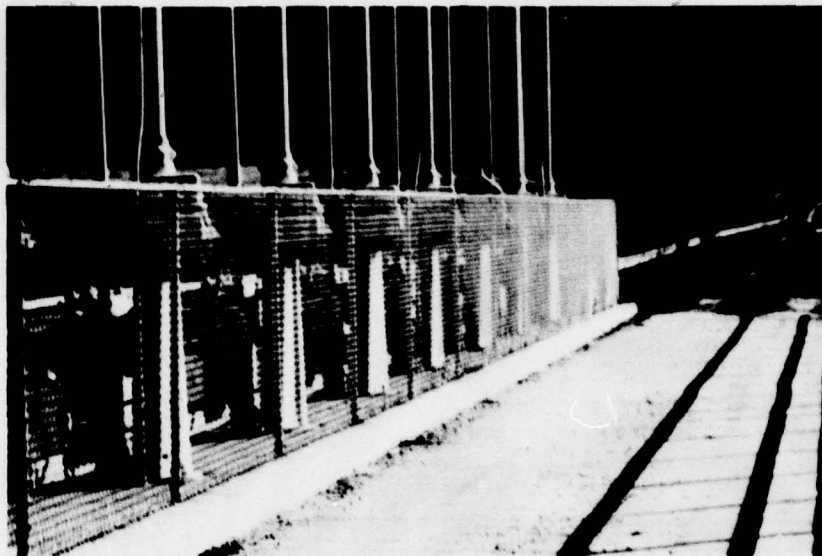
Photo #1

VIEW OF GATE MOTOR ATOP
SPILLWAY BRIDGE

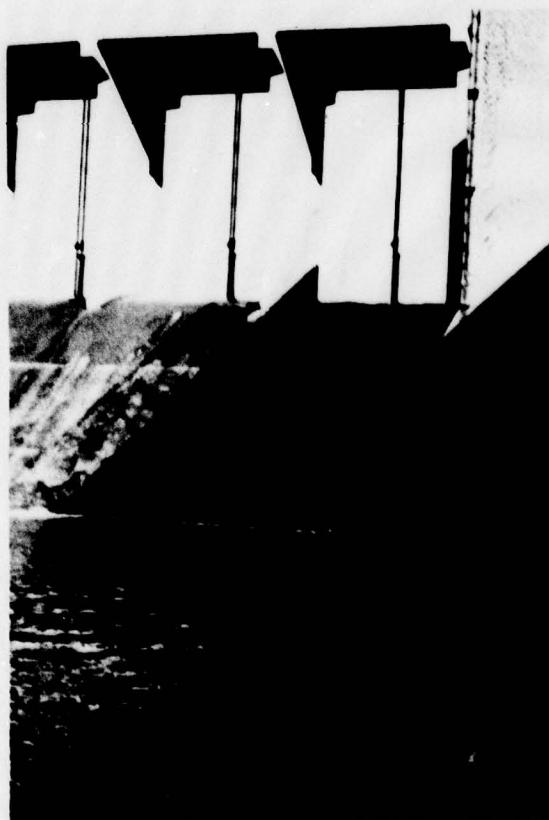
Photo #2

VIEW OF TYPICAL CREST GATE
(GATES IN DOWN POSITION)
(10 GATES TOTAL)

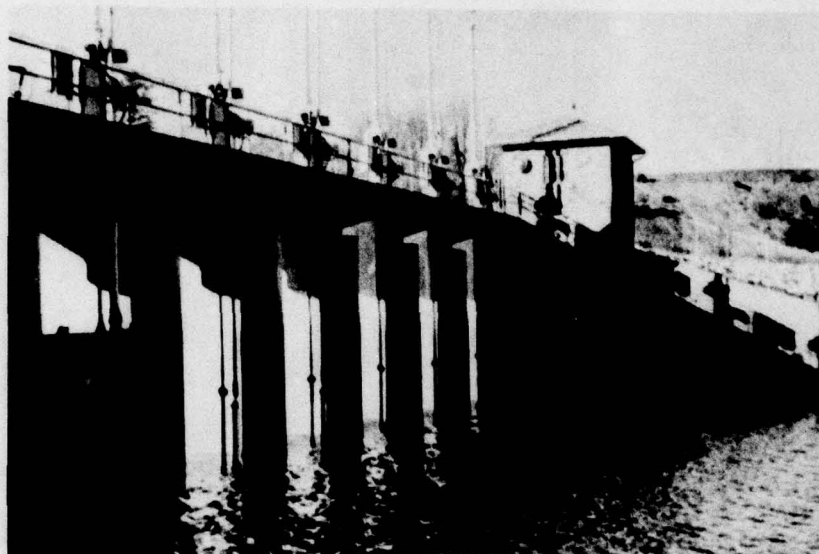
UPSTREAM VIEW OF GATES
(Control Building in Background)
Photo #3

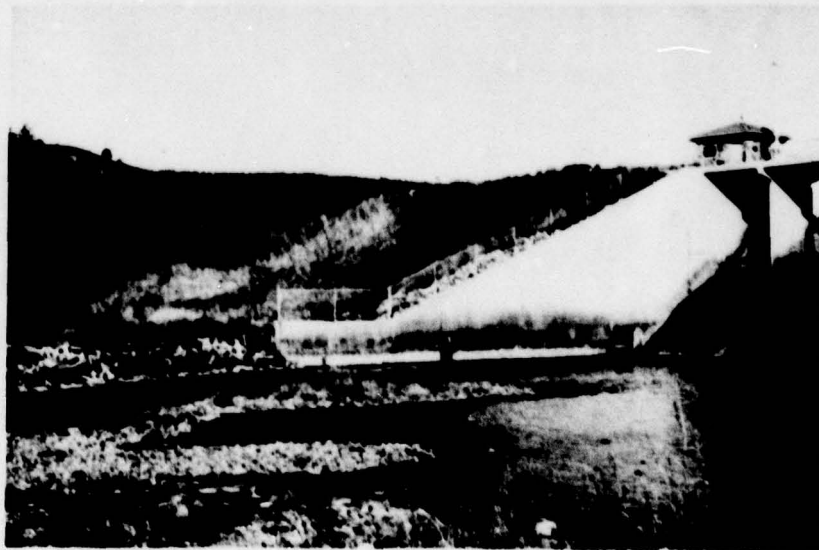
VIEW OF TYPICAL OUTLET WING WALL AT
LOWER EDGE OF SPILLWAY
Photo #6
